Kerfin Inspections:Inc.

Report # / I.D : Girgis
Inspection Date : February 18 2016 **Time :** 4:00pm
Client Name : Mr Rita Girgis
Property Address : 1428 - 1430 W. Hillgrove Western Springs, IL

Type Of Inspection: Pre-Purchase Inspection

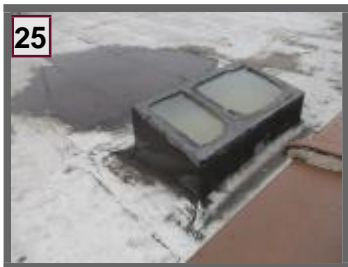
25 Skylights are at the end of there life span.

Skylights have significant damage and total replacement is needed.

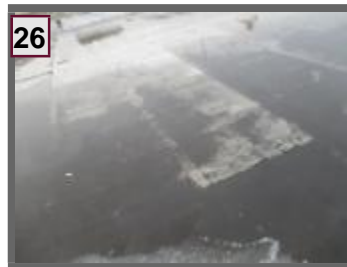
26 Significant amounts of standing water exists on the roof.

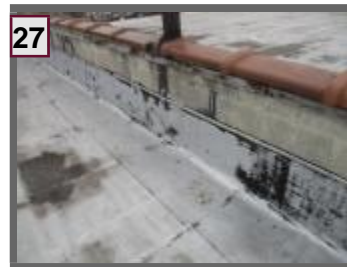
27 Parapet walls need to be weather proofed.

The roof is at the end of its life span. Recommend replacing, also, recommend seal parapet walls and copping stones are deteriorated.

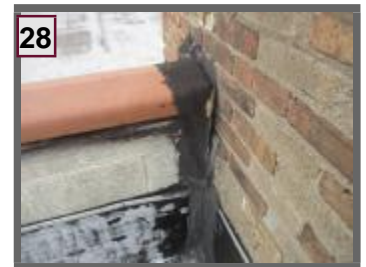
28 Mig shift repairs exist

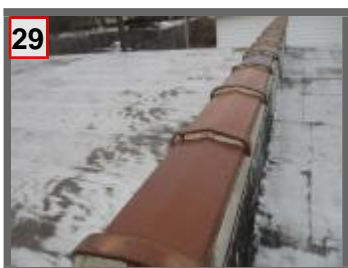
29 Copping stone mortared joints are deteriorated.

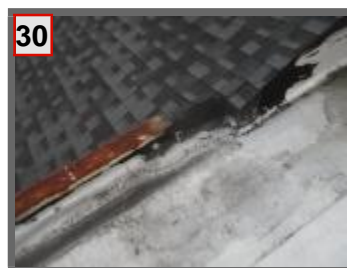
30 Poor repairs have been performed.

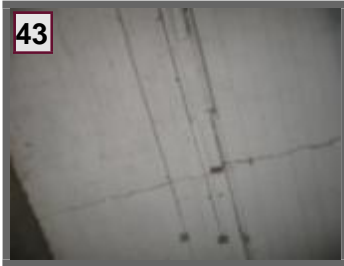
Structure cracks exist.

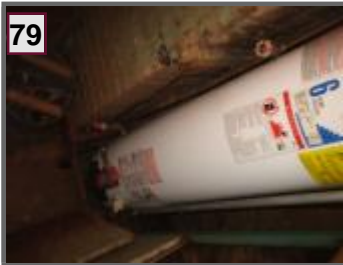
Water heater needs to be replaced.

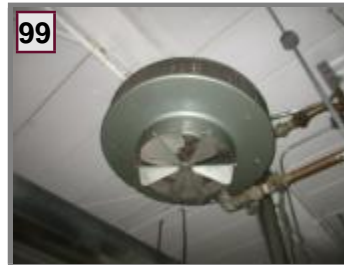
Forced hydro heat exists.

Recommend remove old boiler and install unit heaters.
